Rural Development

Capital Needs Assessment and Replacement Reserve Analysis

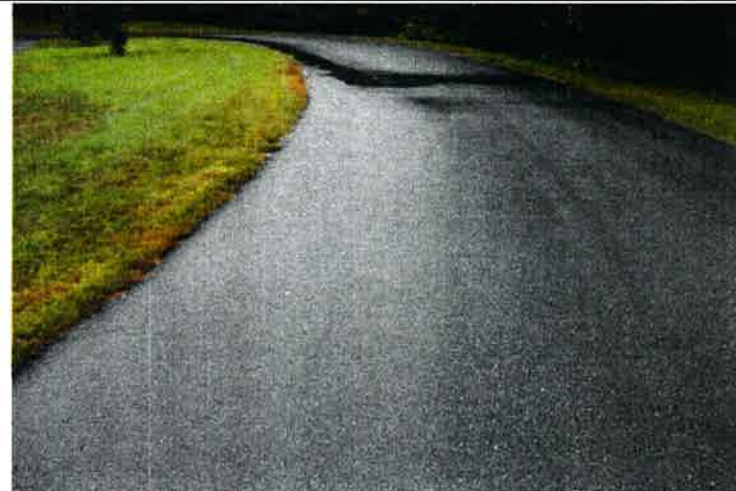
The loop roadway was fully resurfaced in 2013 and remains in generally good observable condition.

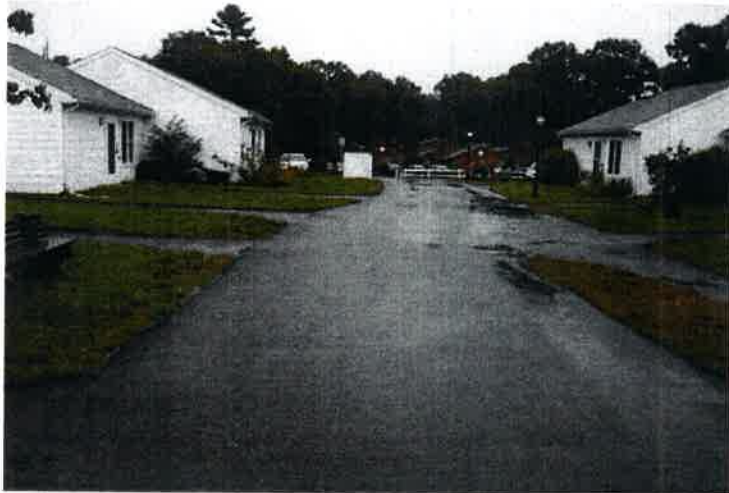
The central roadway running between the two rows of buildings was full fully resurfaced in 2013 as well.

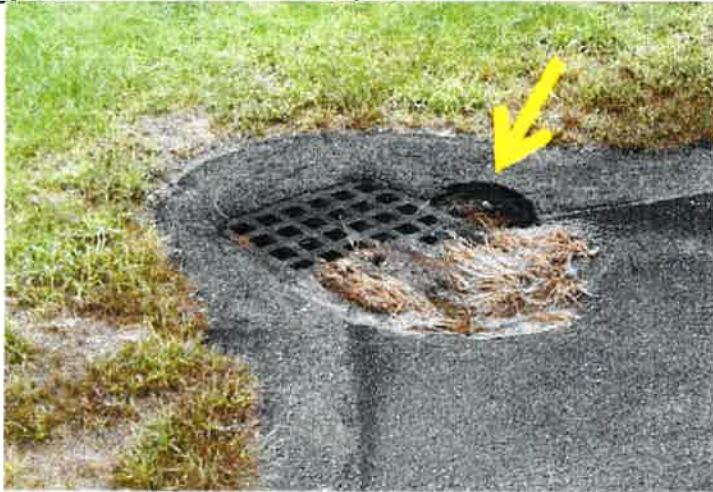
View of sectional asphalt subsidence observed at a drain grate located at the east end of the loop roadway. In need of near-term repair/possible re-setting.

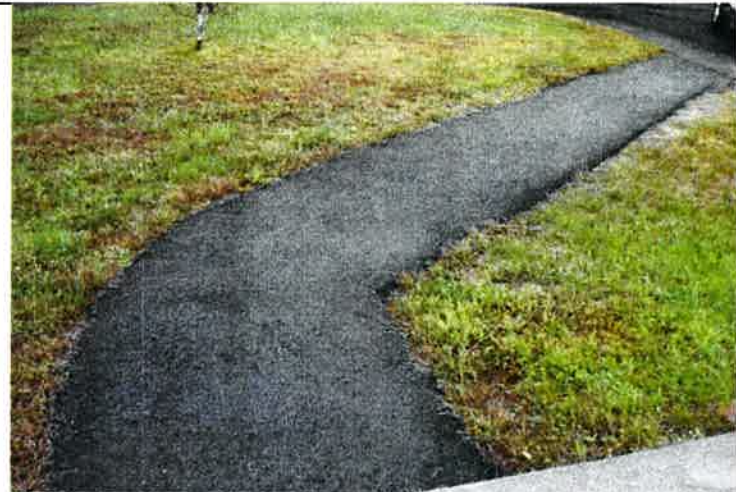
All of the original front-elevation asphalt walkways were fully replaced in 2013; and all new rear-elevation asphalt walkways were installed in 2015.

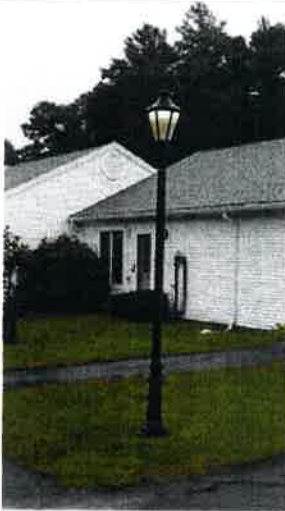
The walkways are lit by a series of post lanterns that were all upgraded with new energy-efficient LED fixtures in 2016.

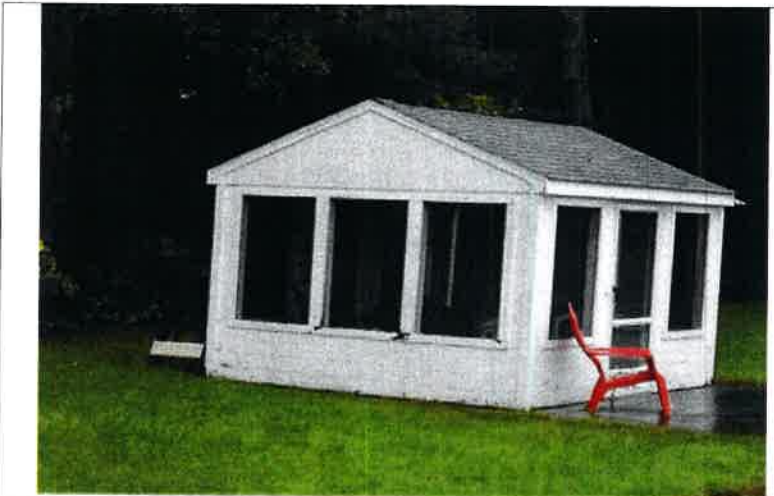
The ageing "Screen House" enclosed patio structure dates to the original 1995 construction as well and exhibits visible age and weather related siding, trim, door, and frame rot.

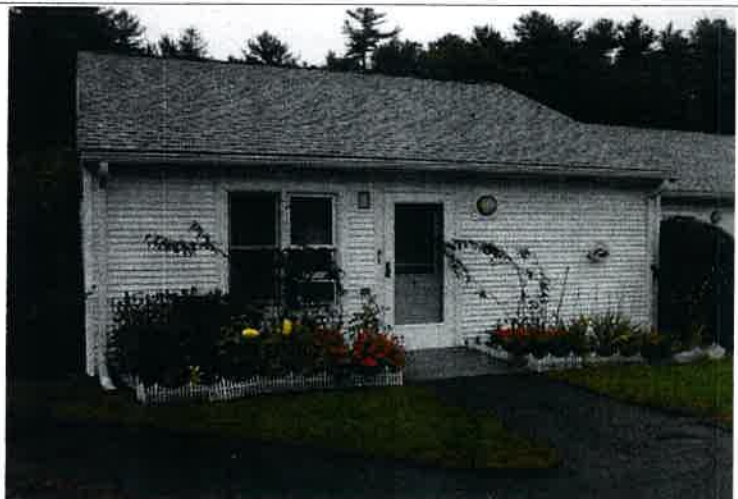
View of typical building/unit front elevation with original (1995) vinyl siding; Harvey vinyl-framed, double-hung windows; half-lite metal-clad entry doors; and recently (2016) installed architectural (dimensional) asphalt shingle roof;

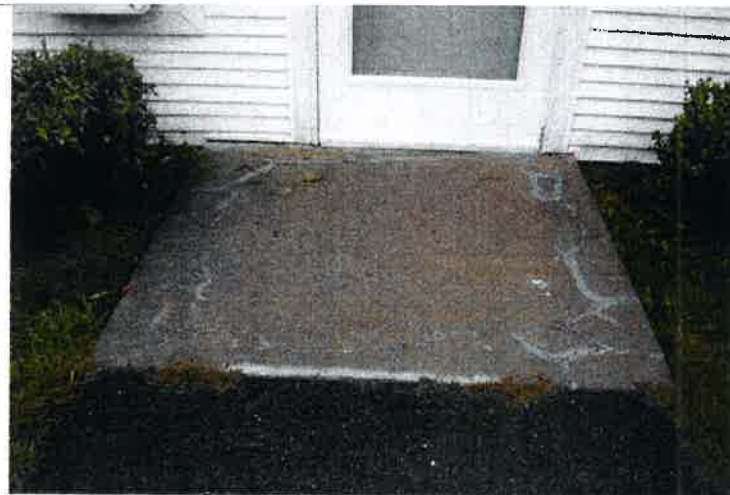
Several of the concrete pads at the dwelling unit front entrance doors have cracked and deteriorated beyond repair and will need to be fully removed and re-poured.

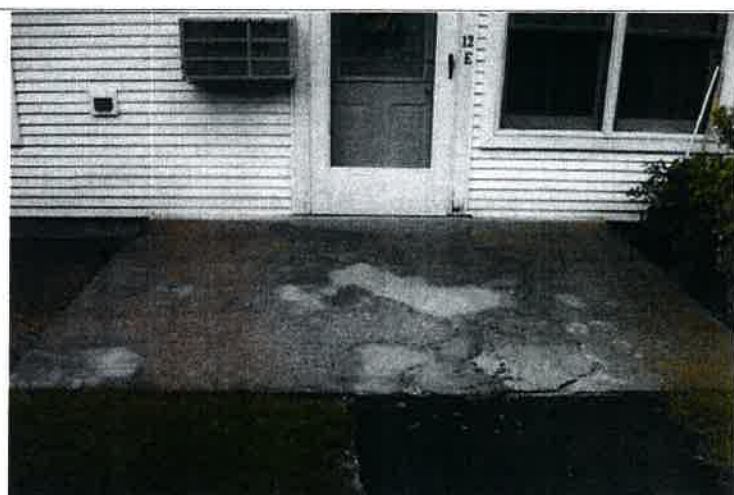
Similar premature concrete deterioration issues exist at the dwelling unit rear-elevation patios. These will need to be fully replaced as well.

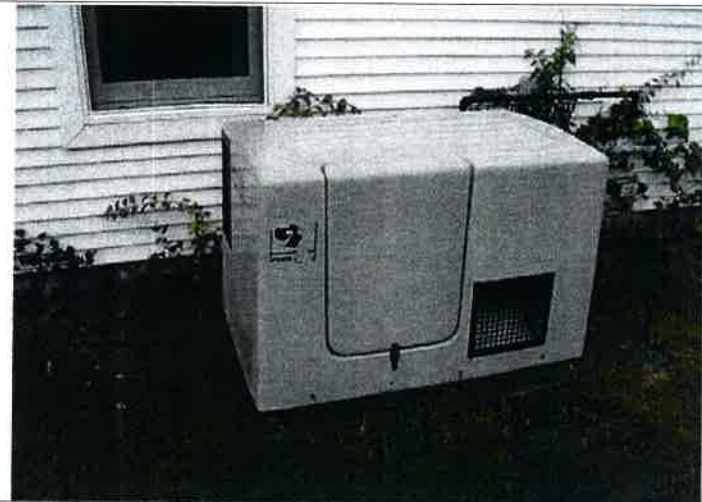
A Sentinel 9, natural gas powered generator located at the west side of the community building provides 9 kW of emergency backup power to the development's life-safety systems during municipal power failures.

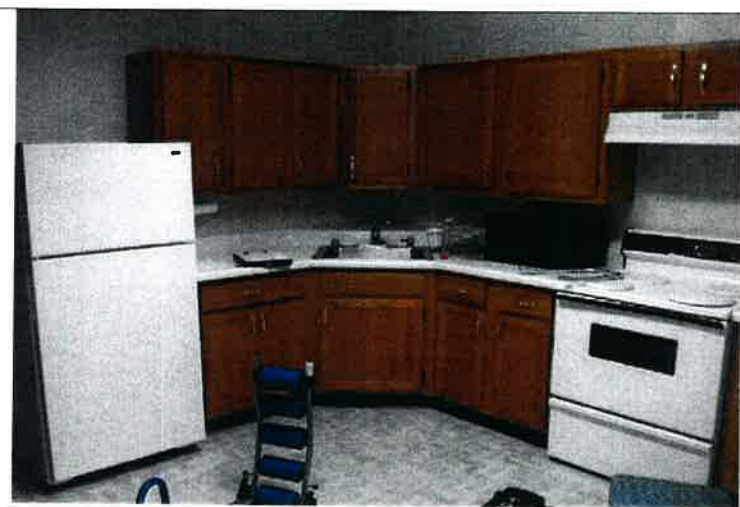
Kitchens feature similar wall and ceiling finishes; vinyl-sheet flooring; wood cabinets; laminate countertops; stainless-steel sinks with disposals; 30-inch electric ranges; ducted rangehoods; and top-freezer refrigerators.

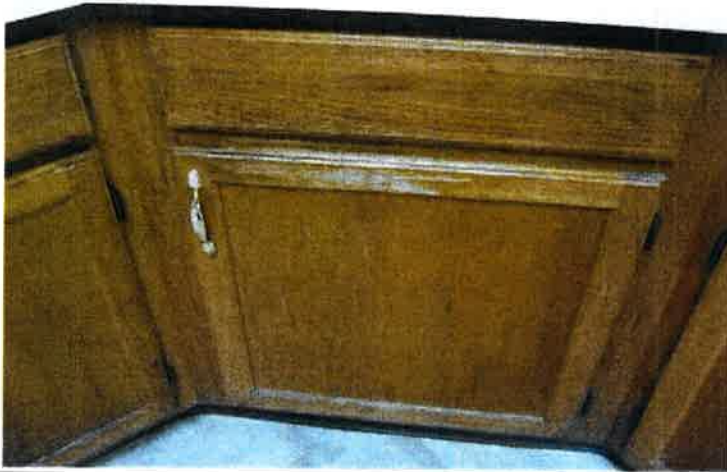
Age and use-related finish wear is visible on some kitchen woodwork. The cabinets all date to the original 1995 construction of the development and are now approaching the end of their 25-year expected useful life.

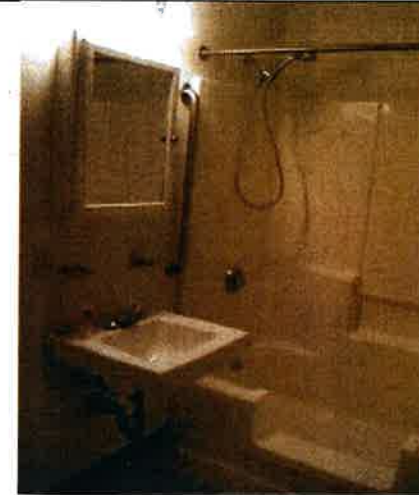
Standard unit bathrooms feature painted drywall walls and ceilings; vinyl-sheet flooring; wall-mounted porcelain sinks and wood medicine cabinets; low-flow toilets; and fiberglass tub-shower assemblies with sidewall cutouts.

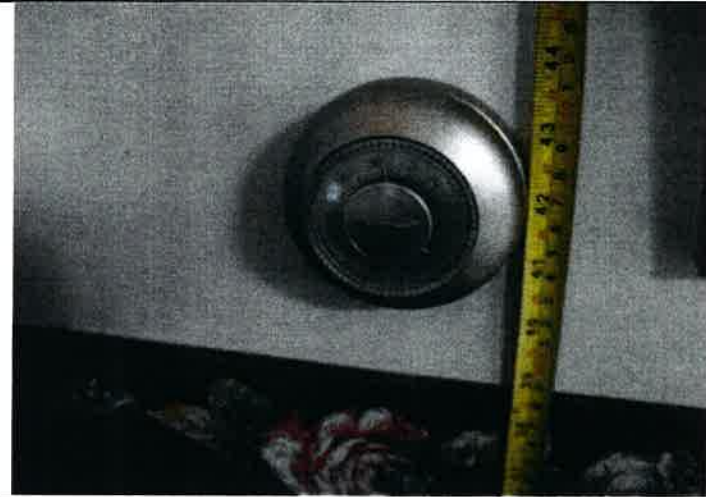
Dwelling units feature Honeywell dial-type thermostats. The accessible unit thermostats are positioned correctly; however they need to be replaced with compliant digital, push-button models that do not require grasping or twisting.

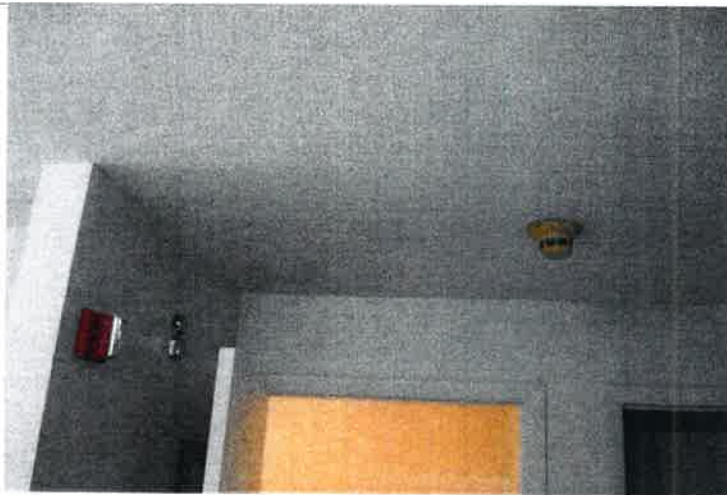
All dwelling units feature hardwired smoke detectors, heat detectors; and audio -visual horn/strobe warning devices connected to the central fire alarm control panel.
